Patching Together a Thousand Pieces.

Tombstones of Tallinn's St Nicholas' Church: History, Restoration and Layout in the Exposition of the Niguliste Museum in the 1970s

MERIKE KURISOO

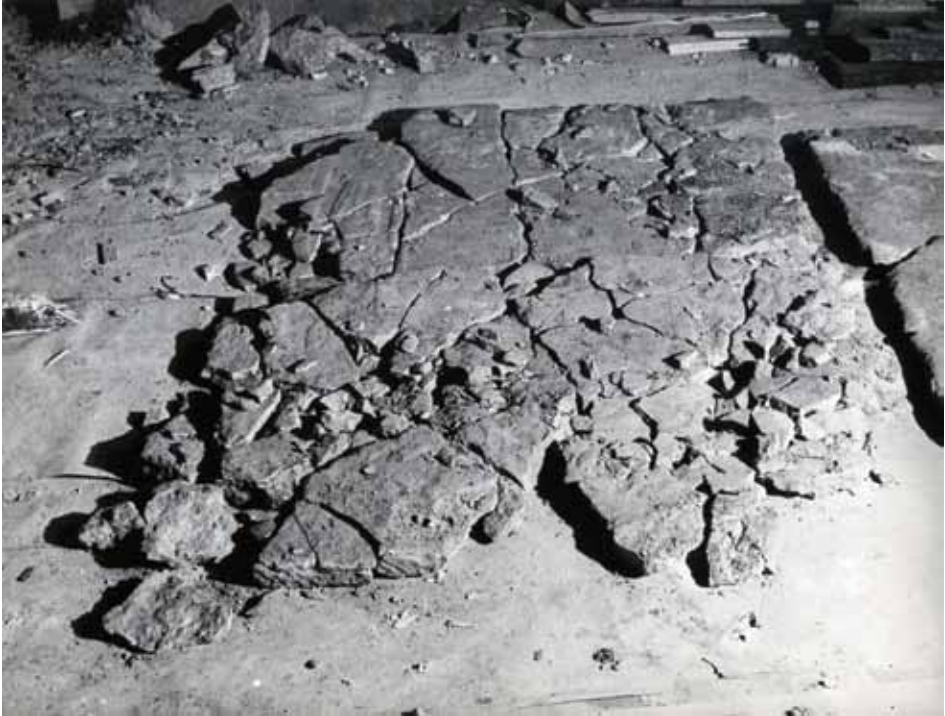
4.

Broken tombstone from the northern aisle of the church before restoration (1970s).
Photo Archives of Tallinn Culture and Heritage Department.

collapsed, breaking most of the tombstones in the nave. The grave markers in St Anthony's Chapel and the North Hall were in a better state. The archival and photo material from the post-war decades gives us an idea of the terrible condition of the tombstones of St Nicholas' Church.²⁰ Of the nearly two hundred tombstones, only a quarter, or approximately 50, had survived by 1969.²¹ The salvageable grave markers were those that had broken into bigger pieces; however, most of the tombstones had been reduced to rubble.

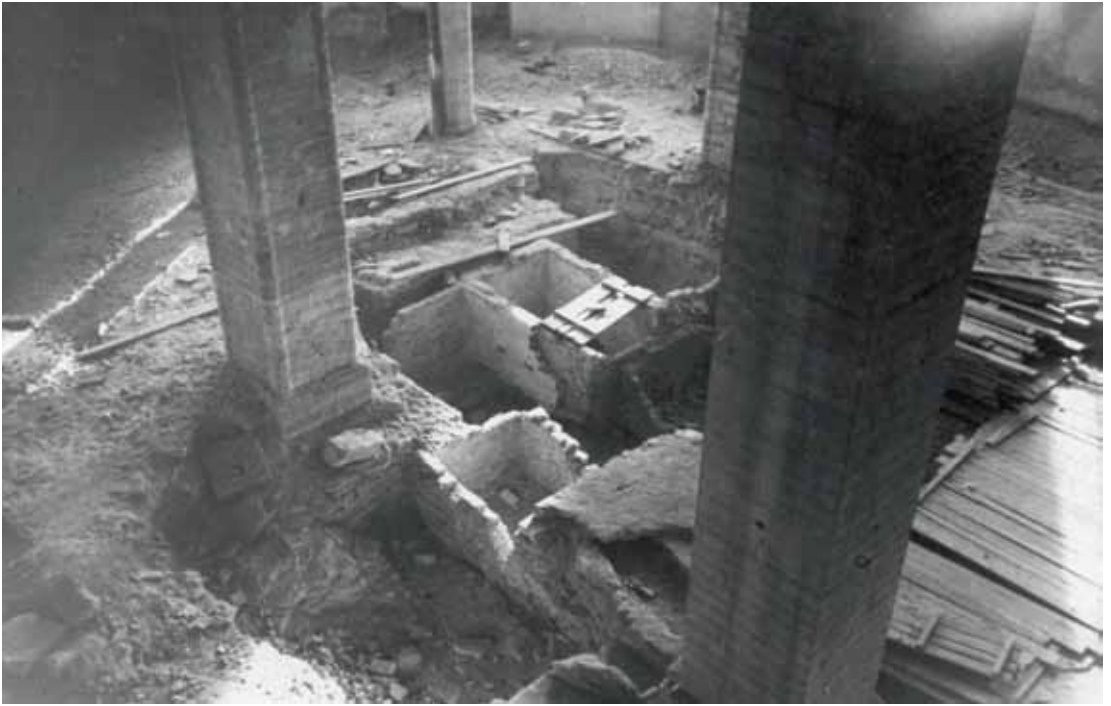
5. Burial chambers in the eastern part of the nave in St Nicholas' Church in 1965.
Photo National Heritage Board.

Hauakambrid Niguliste pikihoone kesklöövi idaosas (1965).
Foto Muinsuskaitseamet.

Being buried inside a church was a privilege in the medieval and early modern periods. Usually the deceased were interred in cemeteries outside of churches. Purchasing a burial chamber in a church was expensive and only the wealthy could afford it. The hierarchy of the locations of burial chambers in a church was a matter of utmost importance. The most prestigious were, as a rule, in the chancel and in the vicinity of altars. As grave markers, tombstones were located on top of the burial chambers, forming the surface of the floor of the church (fig. 5).

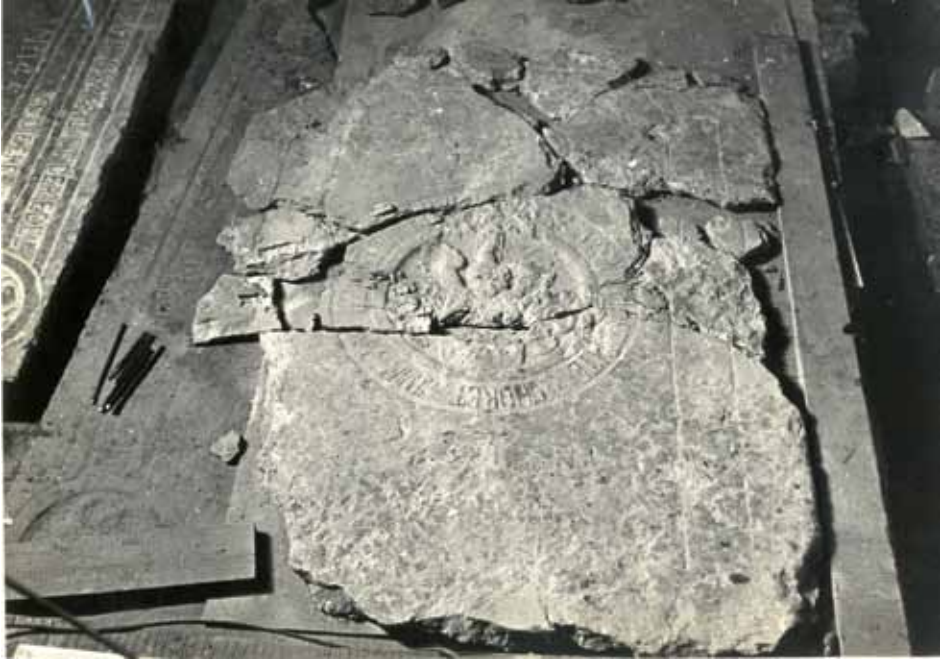
8.

Adam Pampe's broken tombstone before restoration.
Photo Tallinn Culture and Heritage Department.

The leading principle was that all repairs had to be clearly visible, meaning that the original would be easily identified. New areas, such as the corners of the tombstones, were restored only in the general form. The repairs made in the course of restoration can, therefore, still be observed. The lifting and moving of the tombstones was done by hand. The heavy plates, weighing from 500 to 1500 kilos, were moved on rollers. The tombstones of St Anthony's Chapel were, to a large extent, re-carved. The main reason for this was the poor legibility of the worn-out and patched stones. According to Rein Kaur, this was done only on the edges of the ornaments, leaving the bottom surfaces of the decor untouched. On several tombstones, the missing parts of the decor and the original design were marked with slightly accentuated contour lines (figs. 8, 9).

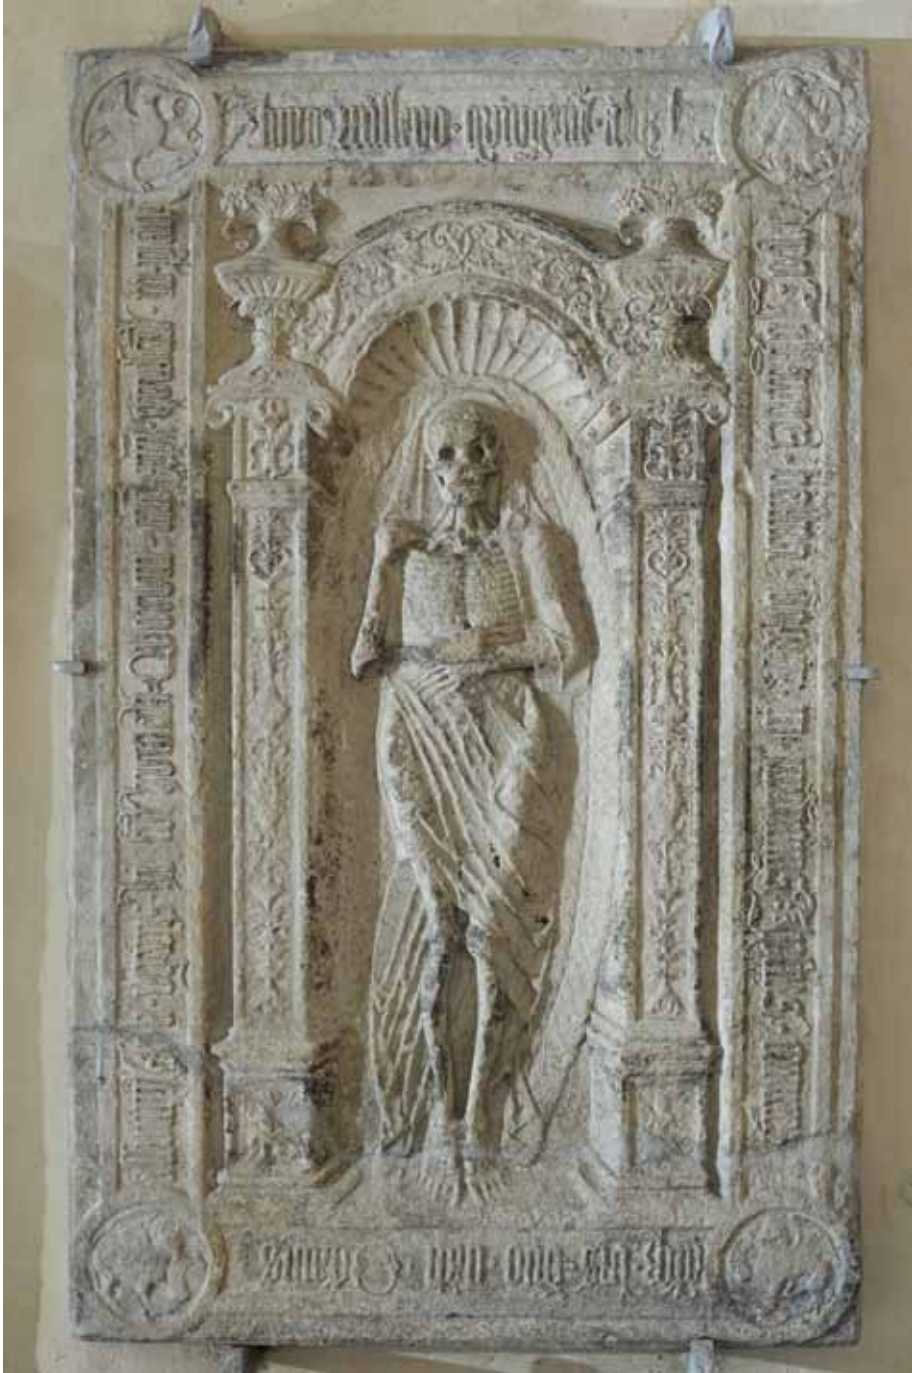
10.

Tombstone of Johannes Ballivi on the wall of the southern aisle in St Nicholas' Church.
Photo Art Museum of Estonia.

The discussion on the layout of the tombstones in St Nicholas' Church continued. The way of exhibiting the tombstones, which had raised questions, was explained by Mai Lumiste as follows: 'The preserved tombstones in the floor of St Matthew's (Anthony's) Chapel and the North Hall were under discussion. The majority of them inside the church had been destroyed. Since it was decided to turn the North Hall, with its relatively new floor, into the main vestibule of Niguliste Museum, there was objectively only one way to keep the traditional floor of tombstones in St Matthew's (Anthony's) Chapel as inherent a component of the historical architecture of the interior as the walls and the vaults.' Most of the tombstones in St Nicholas' Church are located in the floor; however, some of them, especially the figurative, are located on the walls. Especially the latter, vertical presentation raised questions. Mai Lumiste based this presentation on historical traditions. In addition to a number of examples from Europe, she pointed out that the tombstone of Johannes Ballivi had been exhibited for centuries on the outer wall of the North Hall of St Nicholas' Church³⁸ (fig. 10).
